Title: Land contamination assessment
Location: Croxley Green Watercress Farm and Fisheries
Address: Rousebarn lane, Rickmansworth, Hertfordshire, WD3 3GG
Date: 4 August 2008
Document: 5
Version: 001

Type 3 Asbestos Survey
Date: 18.05.07

Property Name: Rousebarn Farm Development

Asbestos Solutions has received an invitation from David Charmers to provide a Type 3 Survey for Rousebarn Farm Development Area, Watford.

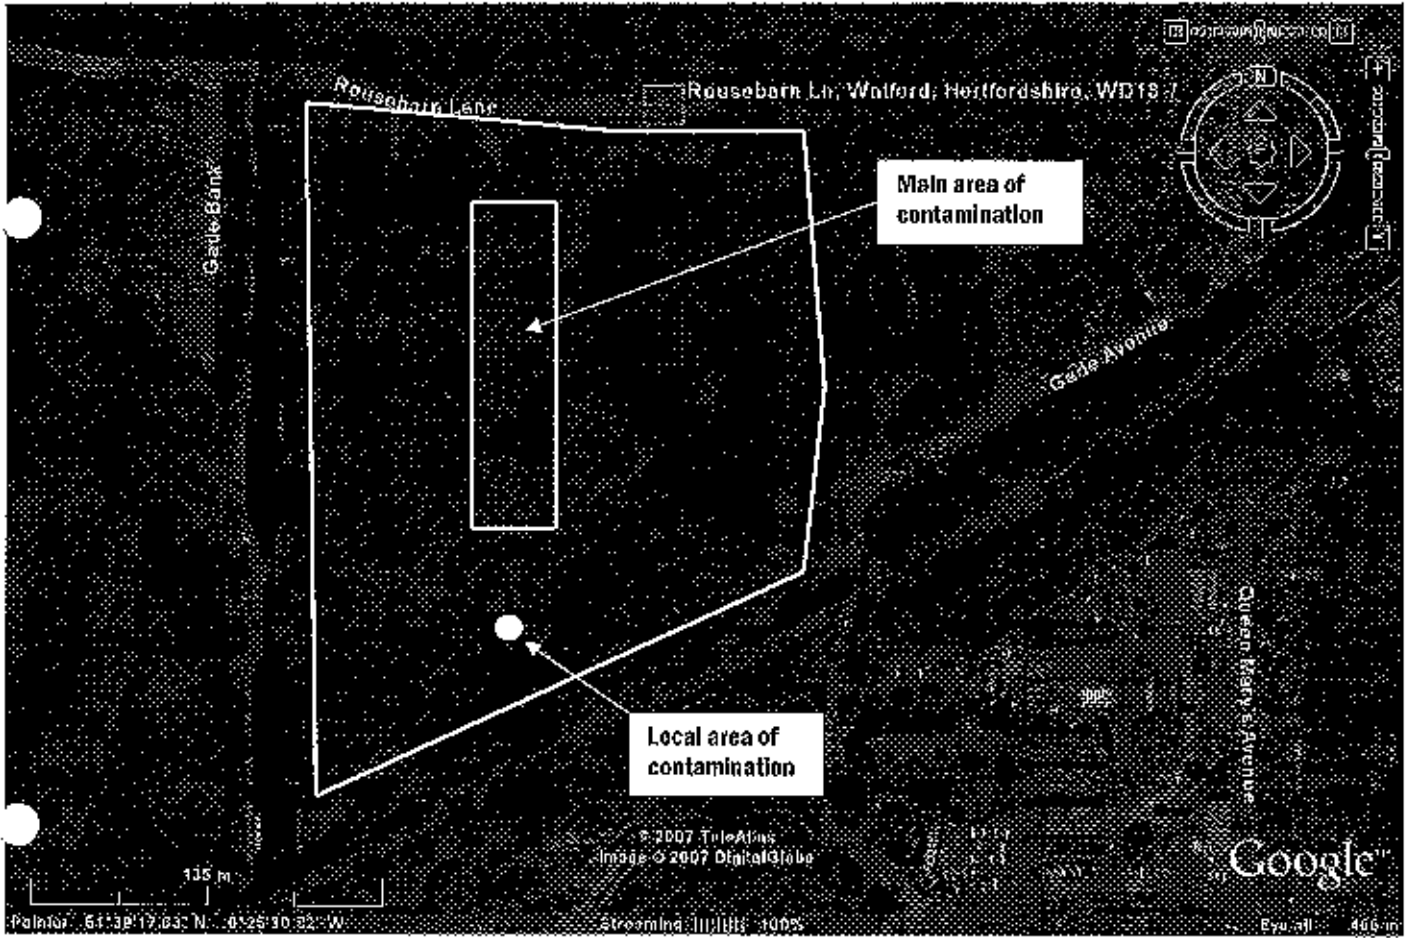
Site Plan A showing sheds & main areas of contamination

The main area of buried asbestos as described in the site plan requires covering with a layer of gravel, hard core or dolomite. This would effectively eliminate any disturbance of the buried asbestos cement.

This is an approximate area of 2500 to 3000 square metres

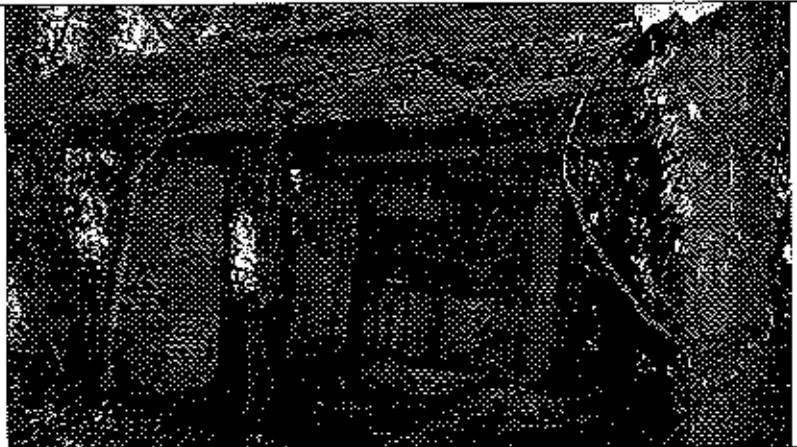
North west corner of site Shed 1			
Material			
Asbestos cement cladding			
Sample Number: 001			
Analytical Result			
Chrysotile			
Observations:			
Material Assessment Algorithm			
Product type	AC		= 1
Extent of damage/deterioration	H		= 3
Surface treatment	C		= 0
Asbestos type	CH		= 1
Total			= 05
Material Assessment Score	05	Potential to release Fibres LOW	
Priority Assessment Algorithm			
Normal Occupant Activity	M =	2	
	S =	2	
Likelihood of Disturbance	L =	0	
	A =	2	
	E =	3	
Human Exposure Potential	N =	3	
	F =	3	
	A =	3	
Maintenance Activity	T =	0	
	F =	0	Total Score = 18
Material Assessment Score	05	Priority Assessment Score	13
		Total Score: 23	
Recommendations		Overall Priority	
Label	Colour Code	1 Immediate Action	
Protect/Enclose	Seal/Encapsulate	2 Over three Months	
Repair	Remove	3 Over Six Months	
NONE		4 Over 1 year	
		5 NONE	
Actions Taken and Date:		Date	
		MAY 2007	
		Review Date	
		MAY 2007

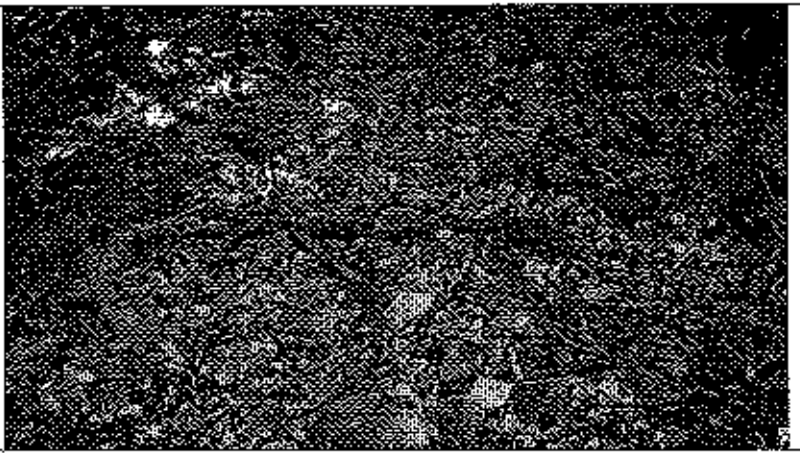
North west corner of site			
Material			
Asbestos cement debris			
Sample Number: 002			
Analytical Result			
Chrysotile			
Observations:			
Material Assessment Algorithm			
Product type	AC	=	1
Extent of damage/deterioration	H	=	3
Surface treatment	C	=	0
Asbestos type	CH	=	1
Total			= 05
Material Assessment Score	05	Potential to release Fibres	LOW
Priority Assessment Algorithm			
Normal Occupant Activity	M =	2	
	S =	2	
Likelihood of Disturbance	L =	0	
	A =	2	
	E =	3	
Human Exposure Potential	N =	3	
	F =	3	
	A =	3	
Maintenance Activity	T =	0	
	F =	0	Total Score = 18
Material Assessment Score	05	Priority Assessment Score	13 Total Score: 23
Recommendations	Colour Code	Overall Priority	
Label	Seal/Encapsulate	1 Immediate Action	
Protect/Enclose	Remove	2 Over three Months	
Repair		3 Over Six Months	
NONE		4 Over 1 year	
		5 NONE	
Actions Taken and Date:		Date	MAY 2007
		Review Date	MAY 2007

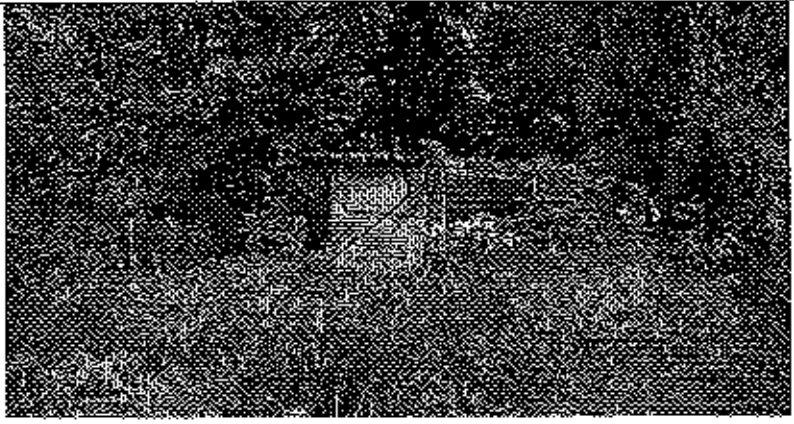
North east corner of site Shed 2			
Material			
Asbestos cement cladding			
Sample Number: 003			
Analytical Result			
Chrysotile			
Observations:			
Material Assessment Algorithm			
Product type	AC		= 1
Extent of damage/deterioration	H		= 3
Surface treatment	C		= 0
Asbestos type	CH		= 1
Total			= 05
Material Assessment Score	05	Potential to release Fibres	LOW
Priority Assessment Algorithm			
Normal Occupant Activity	M =	2	
	S =	2	
Likelihood of Disturbance	L =	0	
	A =	2	
	E =	3	
Human Exposure Potential	N =	3	
	F =	3	
	A =	3	
Maintenance Activity	T =	0	
	F =	0	Total Score = 18
Material Assessment Score	05	Priority Assessment Score	13 Total Score: 23
Recommendations	Colour Code	Overall Priority	
Label	Seal/Encapsulate	1 Immediate Action	
Protect/Enclose	Remove	2 Over three Months	
Repair		3 Over Six Months	
NONE		4 Over 1 year	
		5 NONE	
Actions Taken and Date:		Date	MAY 2007
		Review Date	MAY 2007

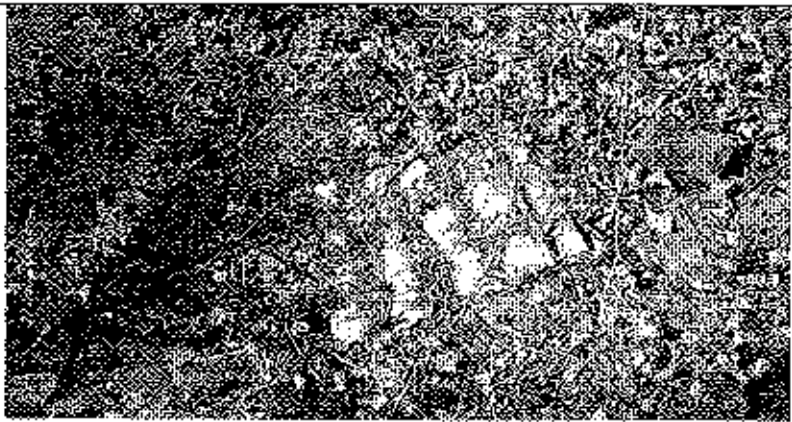
East side of site			
Material			
Asbestos cement debris			
Sample Number: 004			
Analytical Result			
<u>Chrysotile</u>			
Observations:			
Material Assessment Algorithm			
Product type	AC	=	1
Extent of damage/deterioration	H	=	3
Surface treatment	C	=	0
Asbestos type	CH	=	1
Total		=	05
Material Assessment Score	05	Potential to release Fibres	<u>LOW</u>
Priority Assessment Algorithm			
Normal Occupant Activity	M =	2	
	S =	2	
Likelihood of Disturbance	L =	0	
	A =	2	
	E =	3	
Human Exposure Potential	N =	3	
	F =	3	
	A =	3	
Maintenance Activity	T =	0	Total Score = 18
	F =	0	
Material Assessment Score	05	Priority Assessment Score	13
		Total Score: 23	
Recommendations	Colour Code	Overall Priority	
Label		1 Immediate Action	
Protect/Enclose	<u>Seal/Encapsulate</u>	2 Over three Months	
Repair	<u>Remove</u>	3 <u>Over Six Months</u>	
NONE		4 Over 1 year	
		5 NONE	
Actions Taken and Date:		Date	
		MAY 2007	
		Review Date

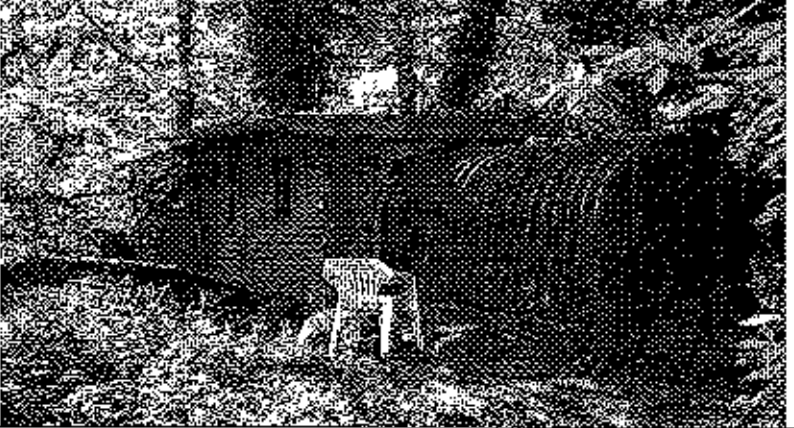
East side of site Shed 3			
Material			
Asbestos cement debris			
Sample Number: 005			
Analytical Result			
Chrysotile			
Observations:			
Material Assessment Algorithm			
Product type	AC	=	1
Extent of damage/deterioration	H	=	3
Surface treatment	C	=	0
Asbestos type	CH	=	1
Total		=	05
Material Assessment Score	05	Potential to release Fibres	LOW
Priority Assessment Algorithm			
Normal Occupant Activity	M =	2	
	S =	2	
Likelihood of Disturbance	L =	0	
	A =	2	
	E =	3	
Human Exposure Potential	N =	3	
	F =	3	
	A =	3	
Maintenance Activity	T =	0	Total Score = 18
	F =	0	
Material Assessment Score	05	Priority Assessment Score	18
		Total Score: 23	
Recommendations		Overall Priority	
Label	Colour Code	1 Immediate Action	
Protect/Enclose	Seal/Encapsulate	2 Over three Months	
Repair	Remove	3 Over Six Months	
NONE		4 Over 1 year	
		5 NONE	
Actions Taken and Date:		Date	
		MAY 2007	
		Review Date	
		MAY 2007

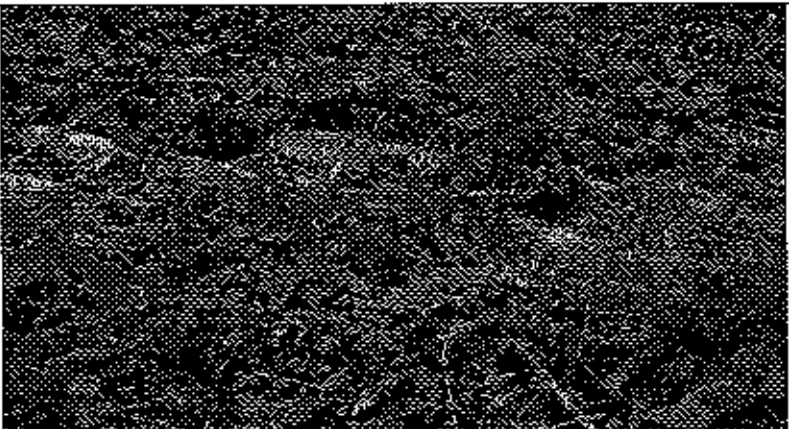
South side of site buried remnants of shed			
Material			
Asbestos cement debris			
Sample Number: 006			
Analytical Result			
Chrysotile			
Observations:			
Material Assessment Algorithm			
Product type	AC	=	1
Extent of damage/deterioration	H	=	3
Surface treatment	C	=	0
Asbestos type	CH	=	1
Total		=	05
Material Assessment Score	05	Potential to release Fibres	LOW
Priority Assessment Algorithm			
Normal Occupant Activity	M =	2	
	S =	2	
Likelihood of Disturbance	L =	0	
	A =	2	
	E =	3	
Human Exposure Potential	N =	3	
	F =	3	
	A =	3	
Maintenance Activity	T =	0	0 Total Score = 18
	F =	0	
Material Assessment Score	05	Priority Assessment Score	13 Total Score: 23
Recommendations		Overall Priority	
Label	Colour Code	1 Immediate Action	
Protect/Enclose	Seal/Encapsulate	2 Over three Months	
Repair	Remove	3 Over Six Months	
NONE		4 Over 1 year	
		5 NONE	
Actions Taken and Date:		Date MAY 2007	
		Review Date MAY 2007

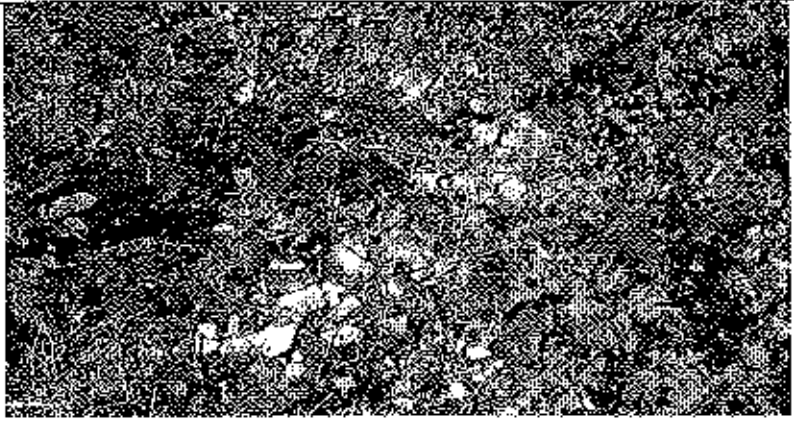
Central site main area for contamination			
Material			
Asbestos cement debris			
Sample Number: 007			
Analytical Result			
Chrysotile			
Observations:			
Material Assessment Algorithm			
Product type	AC	= 1	
Extent of damage/deterioration	H	= 3	
Surface treatment	C	= 0	
Asbestos type	CH	= 1	
Total		= 05	
Material Assessment Score	05	Potential to release Fibres LOW	
Priority Assessment Algorithm			
Normal Occupant Activity	M =	2	
	S =	2	
Likelihood of Disturbance	L =	0	
	A =	2	
	E =	3	
Human Exposure Potential	N =	3	
	F =	3	
	A =	3	
Maintenance Activity	T =	0	
	F =	0	
		Total Score = 18	
Material Assessment Score	05	Priority Assessment Score	18
		Total Score: 23	
Recommendations		Overall Priority	
Label	Colour Code	1 Immediate Action	
Protect/Enclose	Seal/Encapsulate	2 Over three Months	
Repair	Remove	3 Over Six Months	
NONE		4 Over 1 year	
		5 NONE	
Actions Taken and Date:		Date	
		MAY 2007	
		Review Date	
		MAY 2007

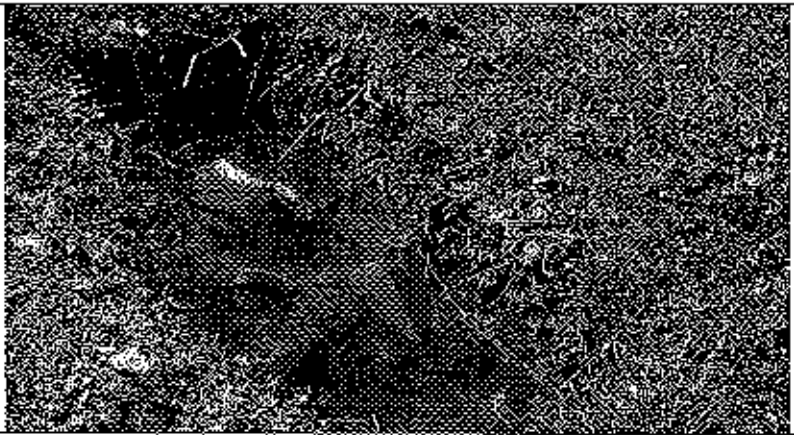
Central site main area for contamination			
Material			
Asbestos cement debris			
Sample Number: 008			
Analytical Result			
<u>Chrysotile</u>			
Observations:			
Material Assessment Algorithm			
Product type	AC	=	1
Extent of damage/deterioration	H	=	3
Surface treatment	C	=	0
Asbestos type	CH	=	1
Total		=	05
Material Assessment Score	05	Potential to release Fibres	<u>LOW</u>
Priority Assessment Algorithm			
Normal Occupant Activity	M =	2	
	S =	2	
Likelihood of Disturbance	L =	0	
	A =	2	
	E =	3	
Human Exposure Potential	N =	3	
	F =	3	
	A =	3	
Maintenance Activity	T =	0	0 Total Score = 18
	F =	0	
Material Assessment Score	05	Priority Assessment Score	13 Total Score: 23
Recommendations		Overall Priority	
Label	Colour Code	1 Immediate Action	
Protect/Enclose	Seal/Encapsulate	2 Over three Months	
Repair	Remove	3 Over Six Months	
NONE		4 Over 1 year	
		5 NONE	
Actions Taken and Date:		Date	
		MAY 2007	
		Review Date

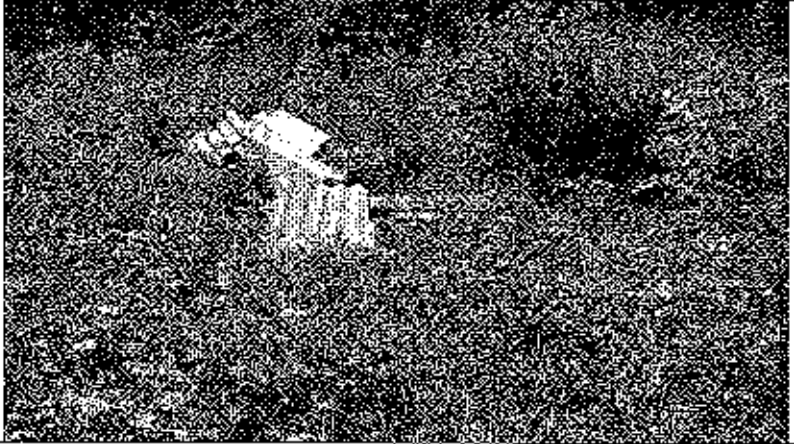
Central site main area for contamination				
Material				
Asbestos cement debris				
Sample Number: 009				
Analytical Result				
Chrysotile				
Observations:				
Material Assessment Algorithm				
Product type	AC	= 1		
Extent of damage/deterioration	H	= 3		
Surface treatment	C	= 0		
Asbestos type	CH	= 1		
Total		= 05		
Material Assessment Score	05	Potential to release Fibres LOW		
Priority Assessment Algorithm				
Normal Occupant Activity	M =	2		
	S =	2		
Likelihood of Disturbance	L =	0		
	A =	2		
	E =	3		
Human Exposure Potential	N =	3		
	F =	3		
	A =	3		
Maintenance Activity	T =	0		
	F =	0		
		Total Score = 18		
Material Assessment Score	05	Priority Assessment Score	18	Total Score: 23
Recommendations: Label Protect/Enclose Repair NONE		Colour Code Seal/Encapsulate Remove	Overall Priority 1 Immediate Action 2 Over three Months 3 Over Six Months 4 Over 1 year 5 NONE	
Actions Taken and Date:		Date MAY 2007 Review Date MAY 2007

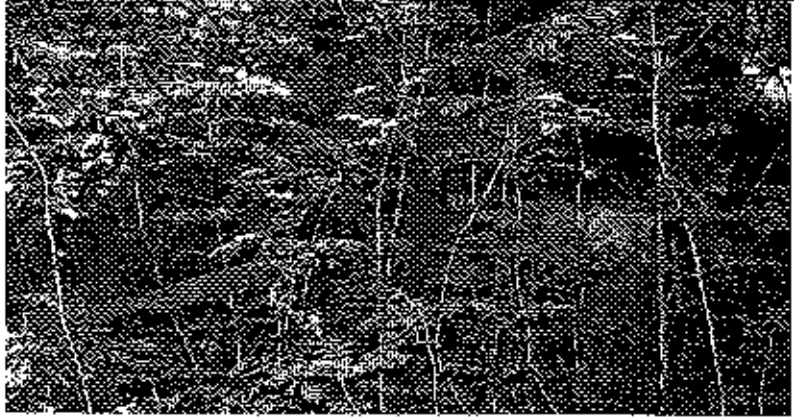
Central site main area for contamination			
Material			
Asbestos cement debris			
Sample Number: 010			
Analytical Result			
<u>Chrysotile</u>			
Observations:			
Material Assessment Algorithm			
Product type	AC	=	1
Extent of damage/deterioration	H	=	3
Surface treatment	C	=	0
Asbestos type	CH	=	1
Total		=	05
Material Assessment Score	05	Potential to release Fibres	LOW
Priority Assessment Algorithm			
Normal Occupant Activity	M =	2	
	S =	2	
Likelihood of Disturbance	L =	0	
	A =	2	
	E =	3	
Human Exposure Potential	N =	3	
	F =	3	
	A =	3	
Maintenance Activity	T =	0	Total Score = 18
	F =	0	
Material Assessment Score	05	Priority Assessment Score	18 Total Score: 23
Recommendations	Overall Priority		
Label	Colour Code	1 Immediate Action	
Protect/Enclose	<u>Seal/Encapsulate</u>	2 Over three Months	
Repair	<u>Remove</u>	3 Over Six Months	
NONE		4 Over 1 year	
		5 NONE	
Actions Taken and Date:	Date		
	MAY 2007		
	Review Date

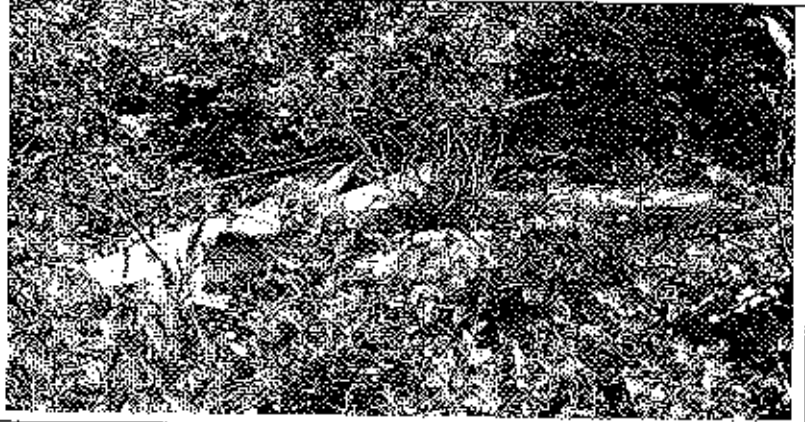
Central site main area for contamination			
Material			
Asbestos cement debris			
Sample Number: 011			
Analytical Result			
Chrysotile			
Observations:			
Material Assessment Algorithm			
Product type	AC	=	1
Extent of damage/deterioration	H	=	3
Surface treatment	C	=	0
Asbestos type	CH	=	1
Total		=	05
Material Assessment Score	05	Potential to release Fibres	LOW
Priority Assessment Algorithm			
Normal Occupant Activity	M =	2	
	S =	2	
Likelihood of Disturbance	L =	0	
	A =	2	
	E =	3	
Human Exposure Potential	N =	3	
	F =	3	
	A =	3	
Maintenance Activity	T =	0	Total Score = 18
	F =	0	
Material Assessment Score	05	Priority Assessment Score	13
		Total Score: 23	
Recommendations		Overall Priority	
Label	Colour Code	1 Immediate Action	
Protect/Enclose	Seal/Encapsulate	2 Over three Months	
Repair	Remove	3 Over Six Months	
NONE		4 Over 1 year	
		5 NONE	
Actions Taken and Date:		Date	
		MAY 2007	
		Review Date	
		MAY 2007

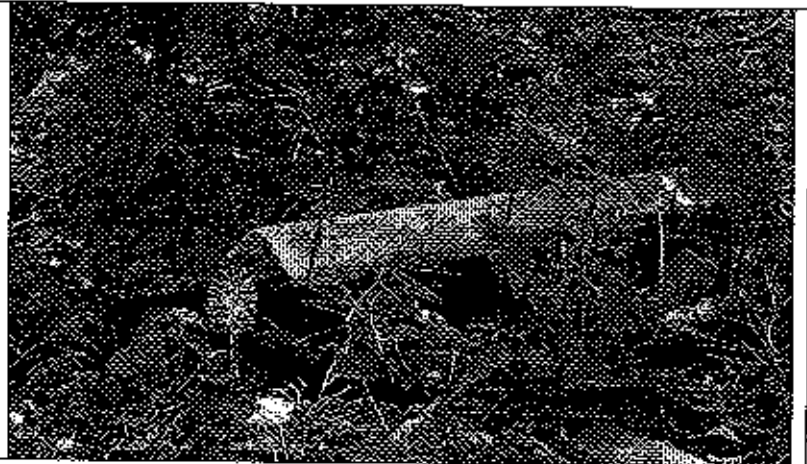
Location
Central site main area for contamination
Material
Asbestos cement debris
Sample Number: 012
Analytical Result
Chrysotile

Product type	AC	= 1
Extent of damage/deterioration	H	= 3
Surface treatment	C	= 0
Asbestos type	CH	= 1
Total		= 05

Recommendations Label Protect/Enclose Repair NONE	Colour Code Seal/Encapsulate Remove	Overall Priority 1 Immediate Action 2 Over three Months 3 Over Six Months 4 Over 1 year 5 NONE
--	--	--

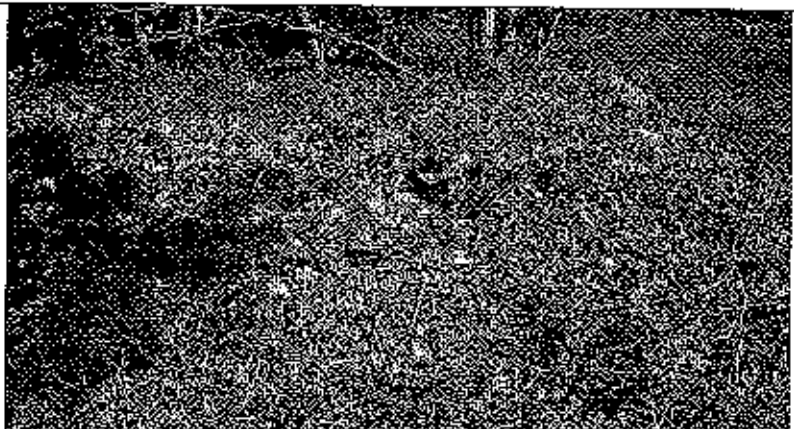
Central site main area for contamination			
Material			
Asbestos cement debris			
Sample Number: 013			
Analytical Result			
Chrysotile			
Observations:			
Material Assessment Algorithm			
Product type	AC	=	1
Extent of damage/deterioration	H	=	3
Surface treatment	C	=	0
Asbestos type	CH	=	1
Total		=	05
Material Assessment Score	05	Potential to release Fibres	LOW
Priority Assessment Algorithm			
Normal Occupant Activity	M =	2	
	S =	2	
Likelihood of Disturbance	L =	0	
	A =	2	
	E =	3	
Human Exposure Potential	N =	3	
	F =	3	
	A =	3	
Maintenance Activity	T =	0	Total Score = 18
	F =	0	
Material Assessment Score	05	Priority Assessment Score	13
		Total Score: 23	
Recommendations		Overall Priority	
Label	Colour Code	1 Immediate Action	
Protect/Enclose	Seal/Encapsulate	2 Over three Months	
Repair	Remove	3 Over Six Months	
NONE		4 Over 1 year	
		5 NONE	
Actions Taken and Date:		Date	
		MAY 2007	
		Review Date	
		MAY 2007

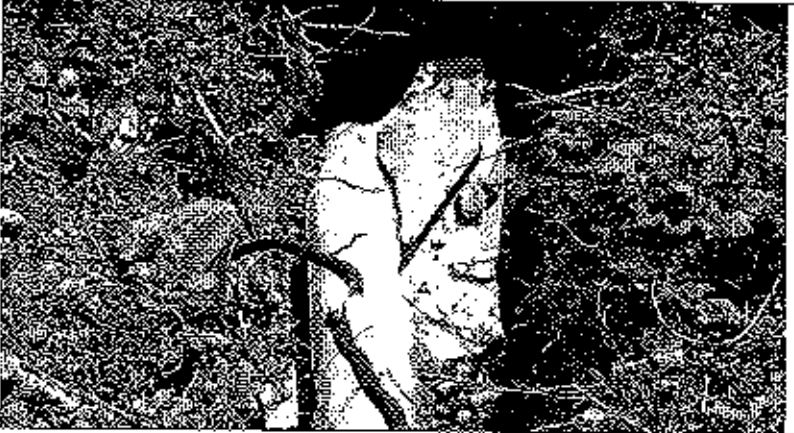
Central site main area for contamination			
Material			
Asbestos cement debris			
Sample Number: 014			
Analytical Result			
Chrysotile			
Observations:			
Material Assessment Algorithm			
Product type	AC	=	1
Extent of damage/deterioration	H	=	3
Surface treatment	C	=	0
Asbestos type	CH	=	1
Total		=	05
Material Assessment Score	05	Potential to release Fibres	LOW
Priority Assessment Algorithm			
Normal Occupant Activity	M =	2	
	S =	2	
Likelihood of Disturbance	L =	0	
	A =	2	
	E =	3	
Human Exposure Potential	N =	3	
	F =	3	
	A =	3	
Maintenance Activity	T =	0	Total Score = 18
	F =	0	
Material Assessment Score	05	Priority Assessment Score	13
		Total Score: 23	
Recommendations	Overall Priority		
Label	Colour Code Seal/Encapsulate Remove	1 Immediate Action	
Protect/Enclose		2 Over three Months	
Repair		3 Over Six Months	
NONE		4 Over 1 year	
		5 NONE	
Actions Taken and Date:	Date		
	MAY 2007		
	Review Date		
	MAY 2007

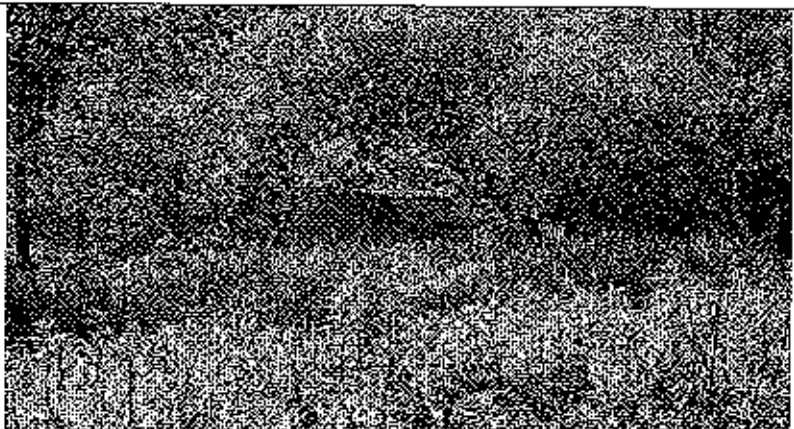
East side of site			
Shed 4			
Material			
Asbestos cement debris			
Sample Number: 015			
Analytical Result			
Chrysotile			
Observations:			
Material Assessment Algorithm			
Product type	AC	=	1
Extent of damage/deterioration	H	=	3
Surface treatment	C	=	0
Asbestos type	CH	=	1
Total		=	05
Material Assessment Score	05	Potential to release Fibres	LOW
Priority Assessment Algorithm			
Normal Occupant Activity	M =		2
	S =		2
Likelihood of Disturbance	L =		0
	A =		2
	E =		3
Human Exposure Potential	N =		3
	F =		3
	A =		3
Maintenance Activity	T =		0
	F =		0
Total Score = 18			
Material Assessment Score	05	Priority Assessment Score	13
		Total Score: 23	
Recommendations		Overall Priority	
Label	Colour Code	1 Immediate Action	
Protect/Enclose	Seal/Encapsulate	2 Over three Months	
Repair	Remove	3 Over Six Months	
NONE		4 Over 1 year	
		5 NONE	
Actions Taken and Date:		Date	
		MAY 2007	
		Review Date	
		MAY 2007

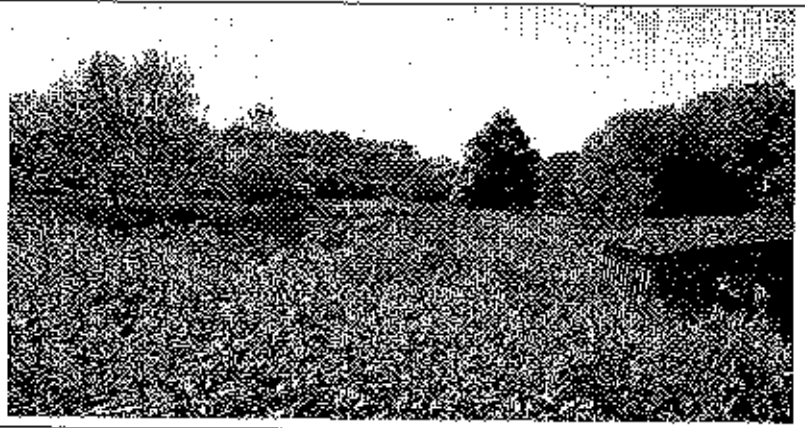
East side of site			
Shed 5			
Material			
Asbestos cement debris			
Sample Number: 016			
Analytical Result			
Chrysotile			
Observations:			
Material Assessment Algorithm			
Product type	AC		= 1
Extent of damage/deterioration	H		= 3
Surface treatment	C		= 0
Asbestos type	CH		= 1
Total			= 05
Material Assessment Score	05	Potential to release Fibres	LOW
Priority Assessment Algorithm			
Normal Occupant Activity	M =	2	
	S =	2	
Likelihood of Disturbance	L =	0	
	A =	2	
	E =	3	
Human Exposure Potential	N =	3	
	F =	3	
	A =	3	
Maintenance Activity	T =	0	Total Score = 18
	F =	0	
Material Assessment Score	05	Priority Assessment Score	13
		Total Score: 23	
Recommendations		Overall Priority	
Label	Colour Code	1 Immediate Action	
Protect/Enclose	Seal/Encapsulate	2 Over three Months	
Repair	Remove	3 Over Six Months	
NONE		4 Over 1 year	
		5 NONE	
Actions Taken and Date:		Date	
		MAY 2007	
		Review Date	
		MAY 2007

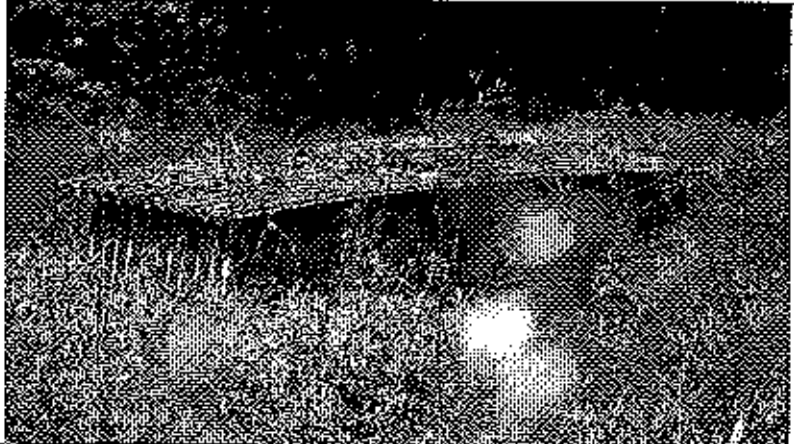
East side of site				
Shed 6				
Material				
Asbestos cement debris				
Sample Number: 017				
Analytical Result				
Chrysotile				
Observations:				
Material Assessment Algorithm				
Product type	AC	=	1	
Extent of damage/deterioration	H	=	3	
Surface treatment	C	=	0	
Asbestos type	CH	=	1	
Total			= 05	
Material Assessment Score	05	Potential to release Fibres	LOW	
Priority Assessment Algorithm				
Normal Occupant Activity	M =	2		
	S =	2		
Likelihood of Disturbance	L =	0		
	A =	2		
	E =	3		
Human Exposure Potential	N =	3		
	F =	3		
	A =	3		
Maintenance Activity	T =	0	0 Total Score = 18	
	F =	0		
Material Assessment Score	05	Priority Assessment Score	13	Total Score: 23
Recommendations	Colour Code Seal/Encapsulate Remove		Overall Priority 1 Immediate Action 2 Over three Months 3 Over Six Months 4 Over 1 year 5 NONE	
Label	NONE			
Protect/Enclose				
Repair				
Actions Taken and Date:			Date MAY 2007 Review Date MAY 2007
