Simon Pryce Arboriculture

**Site:** Proposed new practice ground.

**Subject:** Arboricultural and ecological implications of the proposed creation of the practice ground.

**Reference:** 08/141

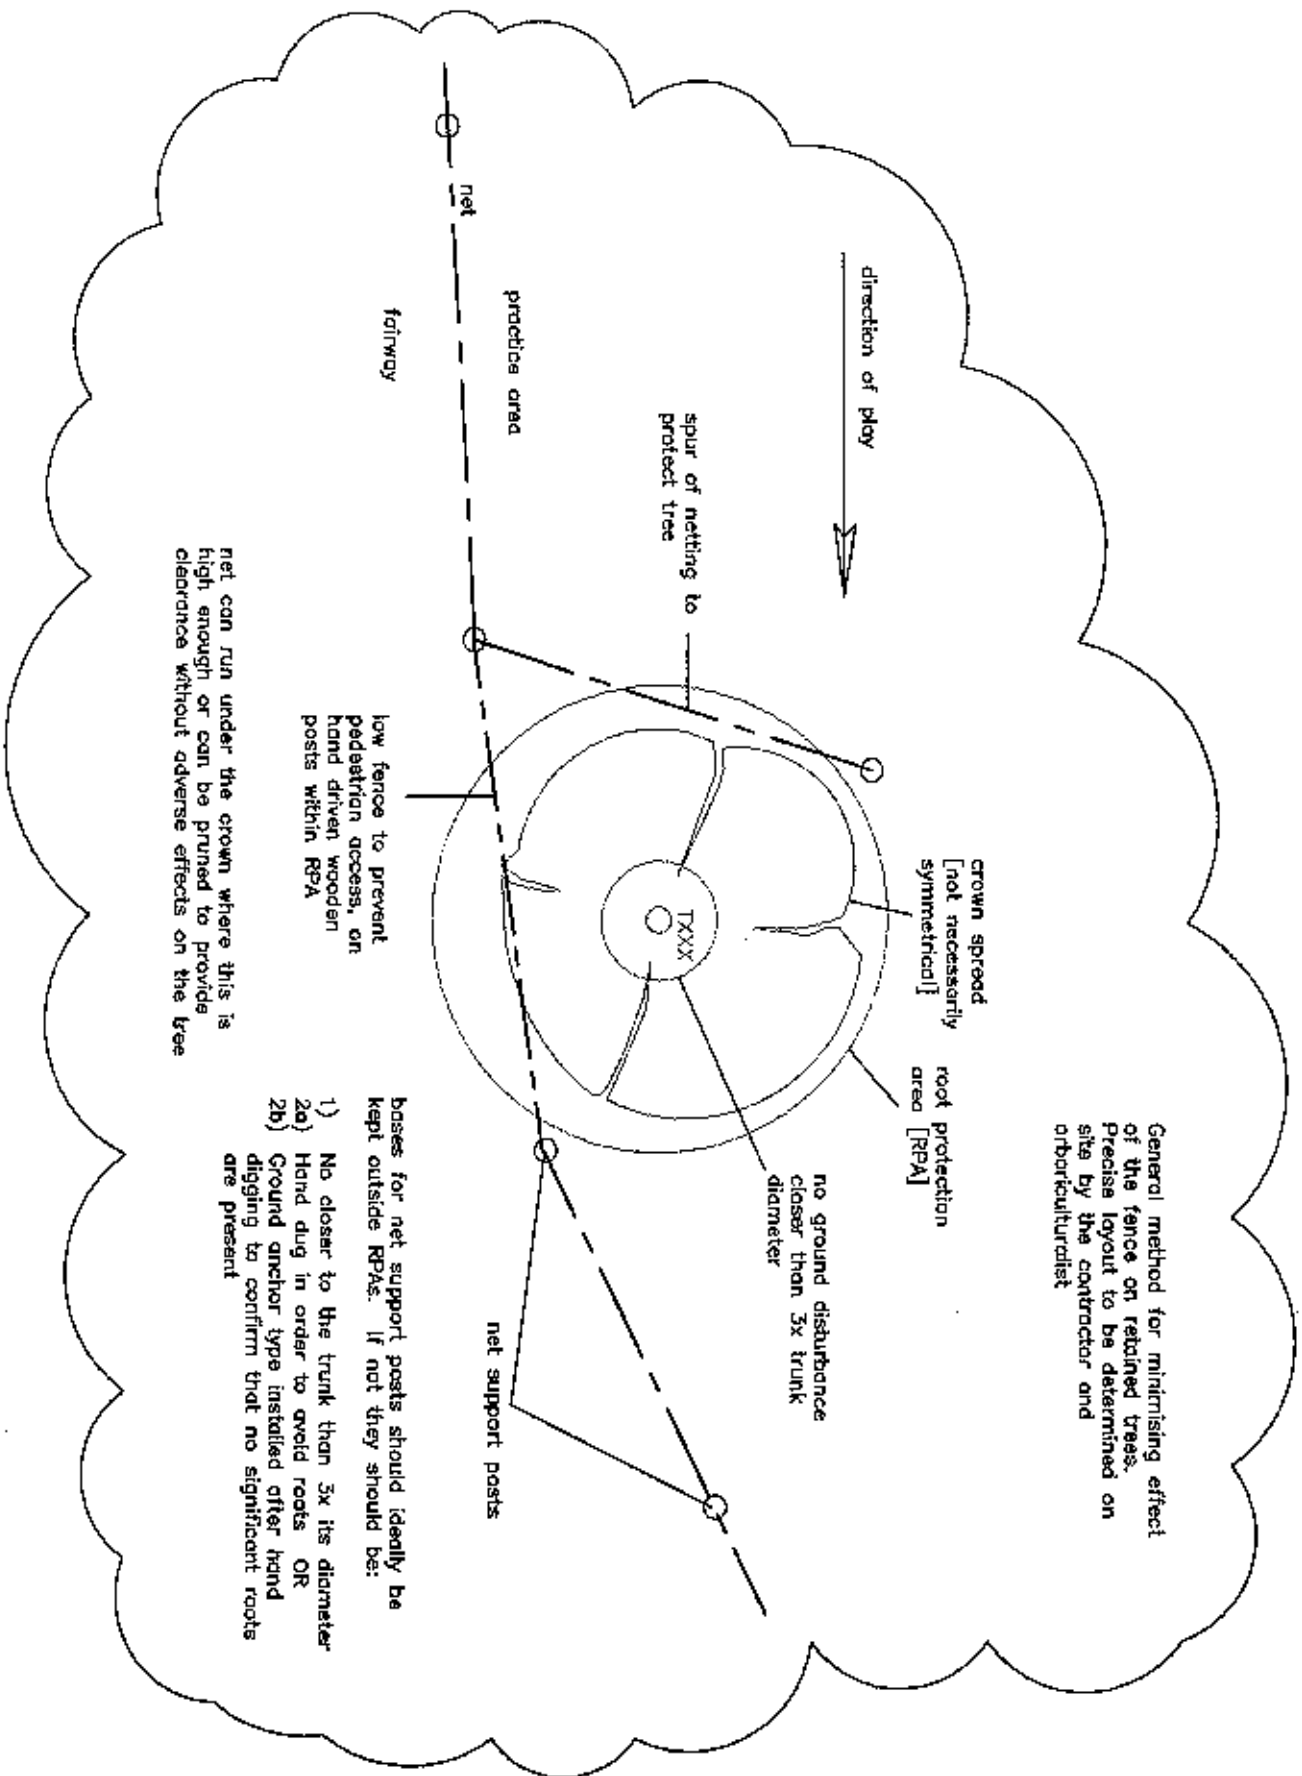
General method for minimising effect of the fence on retained trees. Precise layout to be determined on site by the contractor and arboriculturist

net can run under the crown where this is high enough or can be pruned to provide clearance without adverse effects on the tree

- bases for net support posts should ideally be kept outside RPAs. If not they should be:
- 1) No closer to the trunk than 3x its diameter
  - 2a) Hand dug in order to avoid roots OR
  - 2b) Ground anchor type installed after hand digging to confirm that no significant roots are present

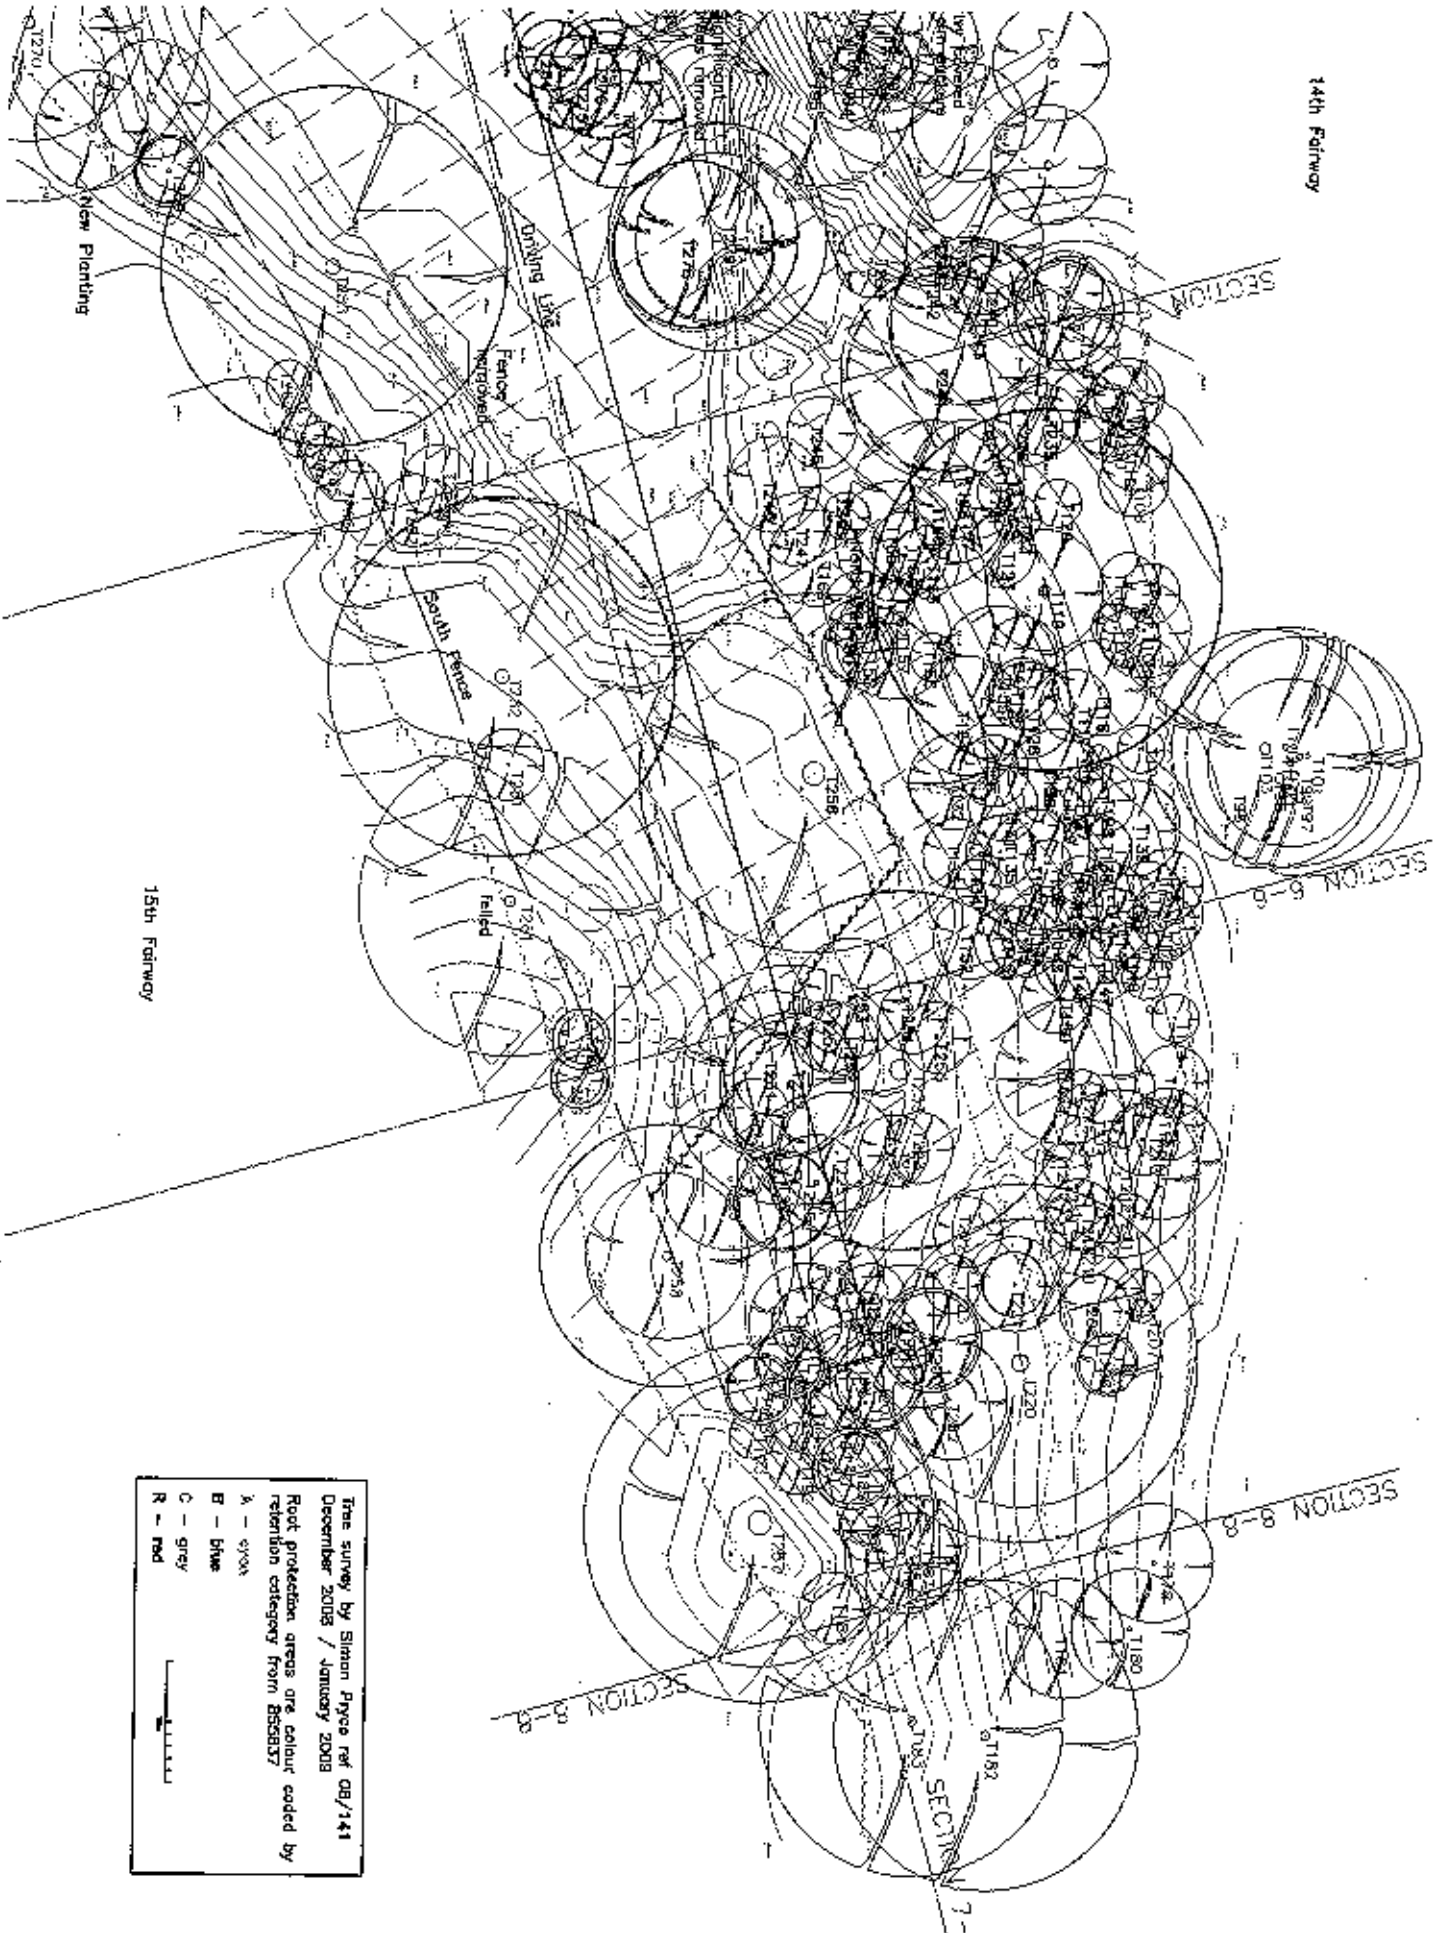
Tree survey by Simon Poyce ref OB/141  
 December 2008 / January 2009  
 Root protection areas are colour coded by  
 retention category from BS5837
