**Arboricultural Implication Assessment and  
Arboricultural Method Statement for a proposed  
development at 61 – 65 Nightingale Road,  
Rickmansworth, Herts**

Henry Homes plc

28<sup>th</sup> May 2008

DS25040701

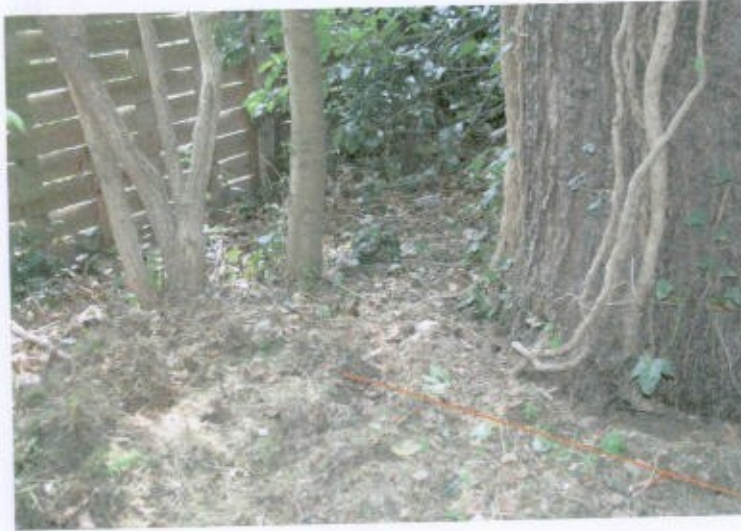
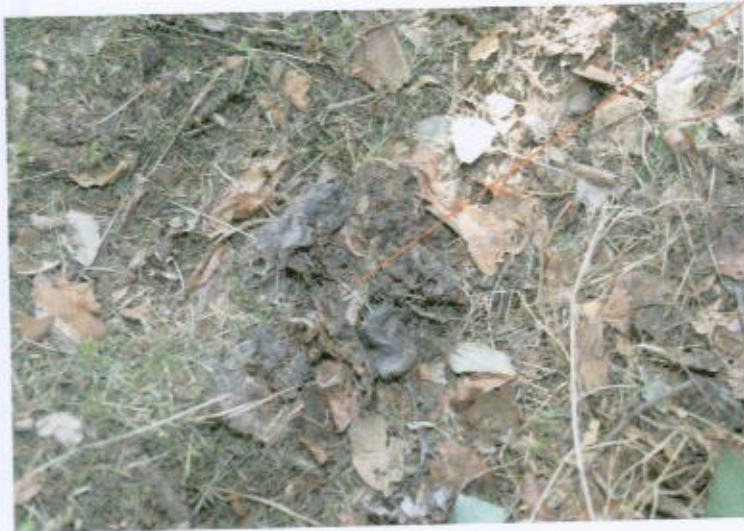
**APPENDIX 2:**  
**Photographs of *Sparassis crispa* fungus at the base of T36**

5.7.1 This is a very large prominent tree covered by a TPO located in the rear garden of 61 Nightingale Road. The condition of this tree is poor: throughout its crown, it has suffered from past storm damage with large wounds from limb failures. It has poor form with long extended limbs which appear vulnerable to future failure. At the base of the tree on the south side, there is an old wound which appears to be the seat of internal decay.

5.7.2 During my preliminary site visit in January 2007, I observed a fruiting body of fungus *Sparassis crispa* emerging from the ground close to the trees base on its east side. This fungus is a well documented brown rot decay pathogen on the roots and butts of conifers, often leading to whole tree failure. During my site visit in January, I was unable to photograph the fungus: I subsequently returned in April 2007 and took photographs of the fruiting body which was partially degraded by this time of year. I have included these photographs as Appendix 2. I had a pre-application site visit with Tree Officer James Percy-Lancaster on 28<sup>th</sup> June 2007 and by this time; the fruiting body (being a fleshy annual) was no longer evident.

Degrading fungal  
fruiting body of  
*Sparassis crispa*

5.7.4 As a consequence of the above, there is strong justification for the removal of this tree. I have shown the tree to be removed in order to facilitate the development. Replacement tree planting is proposed at this site in order to mitigate the loss of removed trees (see tree planting plan).
