**MORNINGSIDE  
8 UXBRIDGE ROAD  
RICKMANSWORTH  
HERTS  
WD3 7AL**

**2008 ECOLOGY REPORT**

**Report July 2008  
By  
Jones & sons  
Environmental Sciences Ltd.  
21-23 North Road  
Hertford  
Herts  
SG14 1LN  
Tel/Fax 01992 552407**

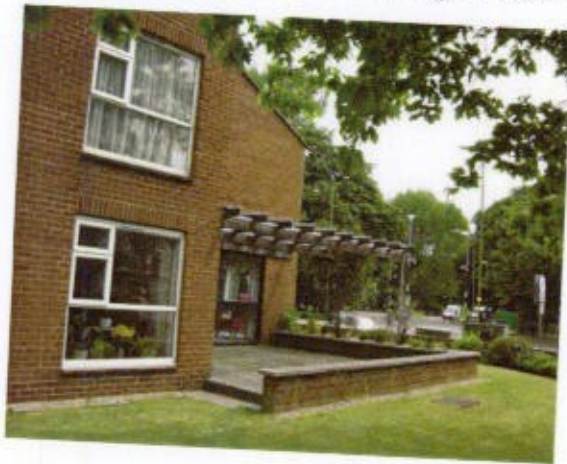
Photograph 2: View from Morningside south towards Rickmansworth Aquadrome

Although the site is located within a busy urban area, the land within the wider area includes extensive water habitats (River Colne, Grand Union Canal, River Chess and flooded gravel pits). The River Colne lies within Rickmansworth Aquadrome just 90 metres to the south and the Aquadrome, to the south of Uxbridge Road, includes a linking series of large lakes (Batchworth Lake, Bury Lake and Stockers Lake). Although the terrestrial habitats within

Rickmansworth Aquadrome support mainly amenity grassland, there are also patches of woodland around the lake margins. Habitats with water, mature trees and woodland are capable of supporting high concentrations of insects of benefit to a variety of bat species.

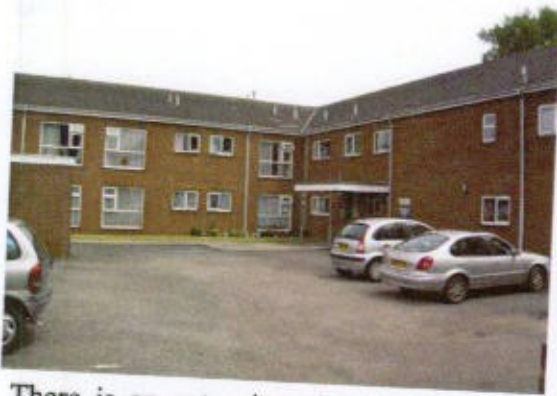
Photograph 3: Building from car park

The two-storey building, dating from the late 1970's, is constructed of breezeblocks and bricks, with a shallow pitched tiled roof.

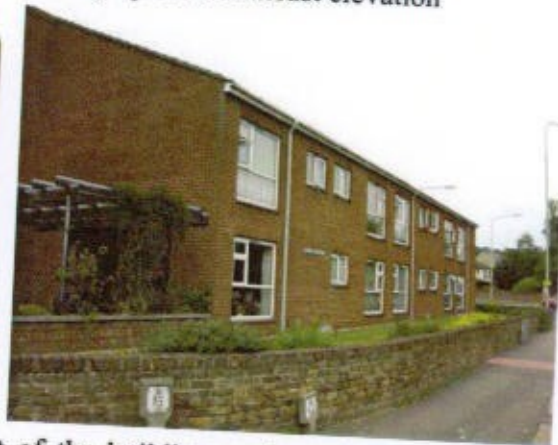
Photograph 4: Southeast elevation

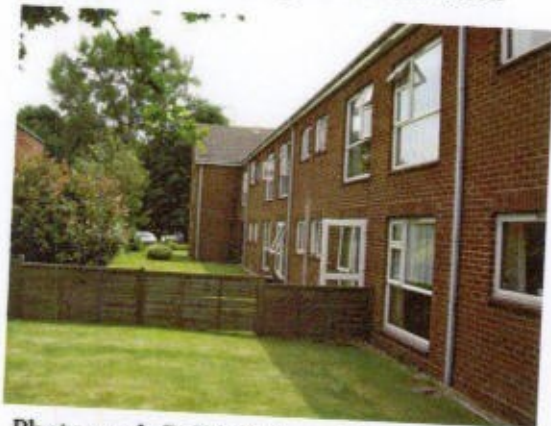
Photograph 5: Rear garden view south

There is an extensive car park to the west of the building, patios adjacent to the building, a short brick wall (c.1 metre in height) and wooden fences bordering and crossing the site. The surrounding lawns support strips of mown short amenity grass with low-level shrub borders. Between Morningside and the Police Station is a bordering hedge approx 2 metres in height. No trees of any significance were recorded within the survey site. The habitats are illustrated in Fig 3.

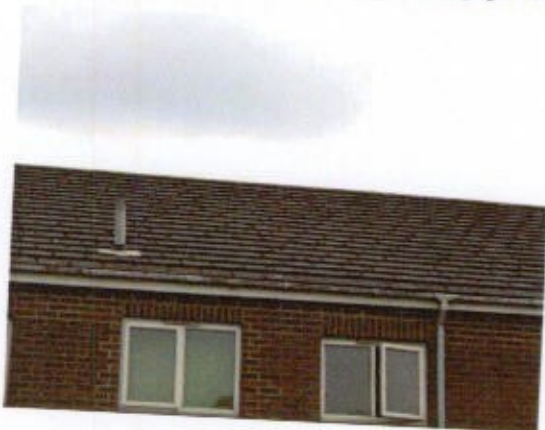
Photograph 7: Roof tiles with no gaps suitable for bat access

The roof tiles are generally in good condition with no missing or loose tiles observed that would be suitable for bats to gain access to the crevices behind the tiles.

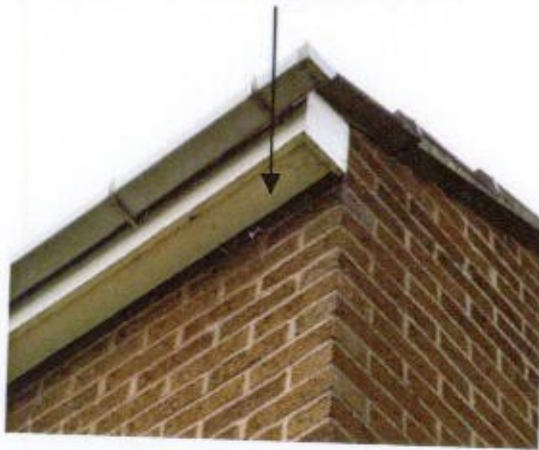
Gaps suitable for bat access however were noted behind some of the timber fascia boarding and between the soffit boards and the wall.

Photograph 8: Gap along soffit boards

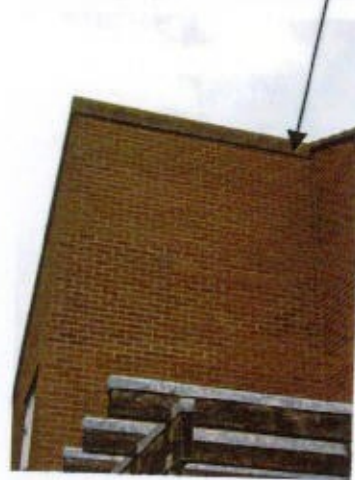
Photograph 9: Fascia board gap

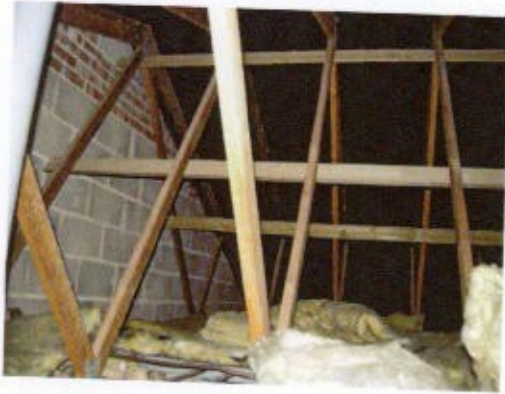
Internally, the building has four separate roof voids, each of which were examined for evidence of use by bats. Bat access to the roof voids is possible through the eaves of the building. All of the lofts are of the same construction, with pre-formed trusses and bitumastic felt lining the roof tiles. The traditional roofing felt provides a potentially favourable surface for any roosting bats. The four lofts vary in size. The loft over the warden's flat and separate loft over the adjacent room are relatively small with a rise to the ridge of approximately 1.8m. The adjacent third loft is wider and longer but with a similar rise to the ridge of c. 1.8 metres. Due to the King posts attached to the ridge and pre-formed trusses the three smaller loft voids provide a cluttered flight area below the ridge and are therefore less favourable for bat species that like to fly within roof voids such as the brown long-eared bat.

Photograph 10: Loft 1

No signs of any current or past use by bats were found inside the lofts.

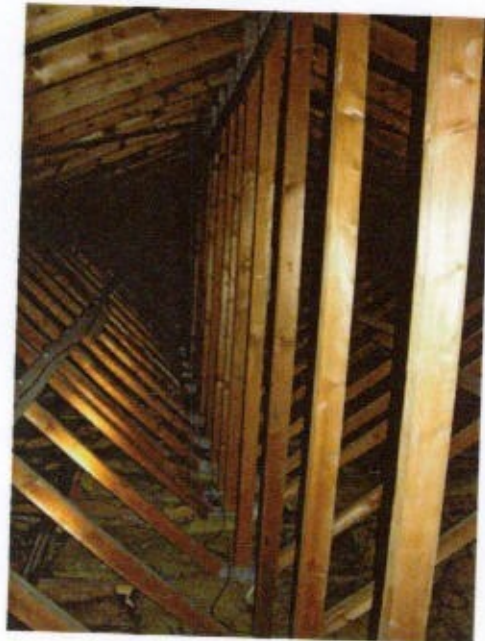
Photograph 11: Long short loft (Loft 3)

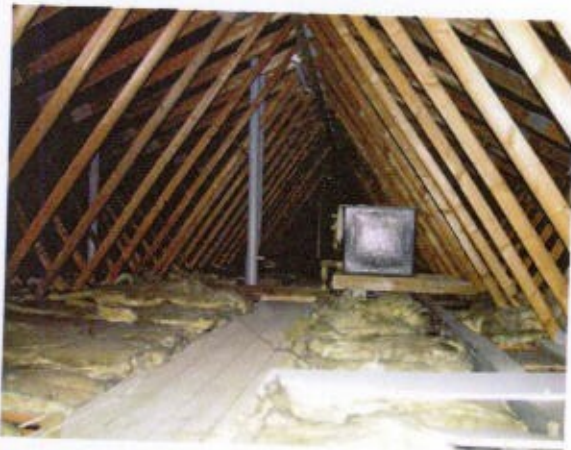
Photograph 12: Southern long tall loft

Running southwest to northeast is a long taller loft that supports dimensions of 50 metres x 10 metres with a rise to the ridge of approximately 3m. There are no king posts in this loft and the large relatively uncluttered space is favourable for roosting bats. However, despite a thorough search no evidence of any bat use was found.

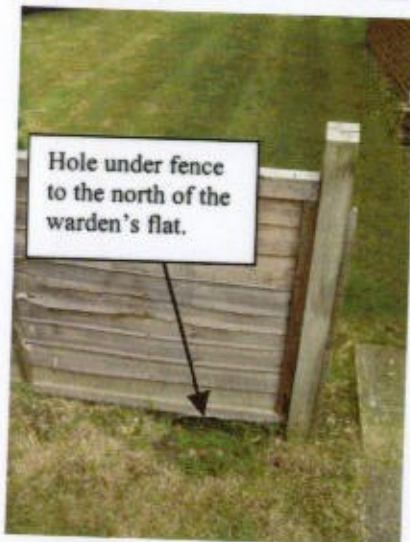
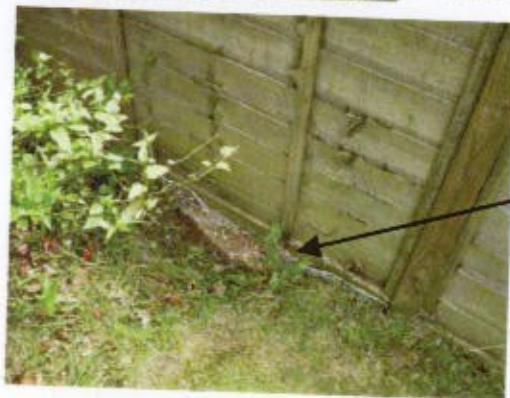
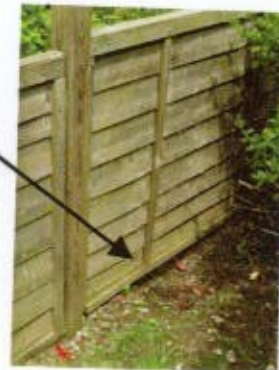
Photograph 13 - 15: Holes under fence used in the past by badgers

Of ecological significance within the site is the report of the presence of badgers by the warden of the site. The site warden reported that a badger had been observed in the garden, during the night, three years previously. The current survey identified two holes under the fences (see plan 3) suitable for badgers to pass under the fence. It was reported that these were more obvious routeways during the last winter. There were no reports of badgers digging into the lawn or garden itself. No badger hair was found on the soil surface of the hole that would have suggested current use by a badger. A hedgehog dropping was found near the fence and it is likely that hedgehogs also pass under the fence.

Hole under fence to the east of the warden's flat viewed from the north and south

The survey found holes under the fences suitable for use by badgers although no current use by badgers was found. Badgers had been reported to cross the site in the past. The data search found no known records for badgers within the area and the site does not support optimal badger foraging habitat. Urban badgers however are increasing in Hertfordshire and it is possible that badgers are foraging within the established gardens along Nightingale Road. The garden of Morningside may be part of a badger's territory used as an occasional foraging area but it is unlikely that it forms part of a regularly used pathway. The current survey would suggest that the development would have no adverse impact on badgers. Due to the fact however that badgers can be unpredictable, it is recommended that any presence of badgers be monitored for any future use of the site.
