**GEO ENVIRONMENTAL  
ASSESSMENT**

**FORMER HAPPY MAN  
PUBLIC HOUSE  
BERRY LANE  
RICKMANSWORTH  
HERTFORDSHIRE**

**22852-R01 (00)**

**TESCO STORES LTD**

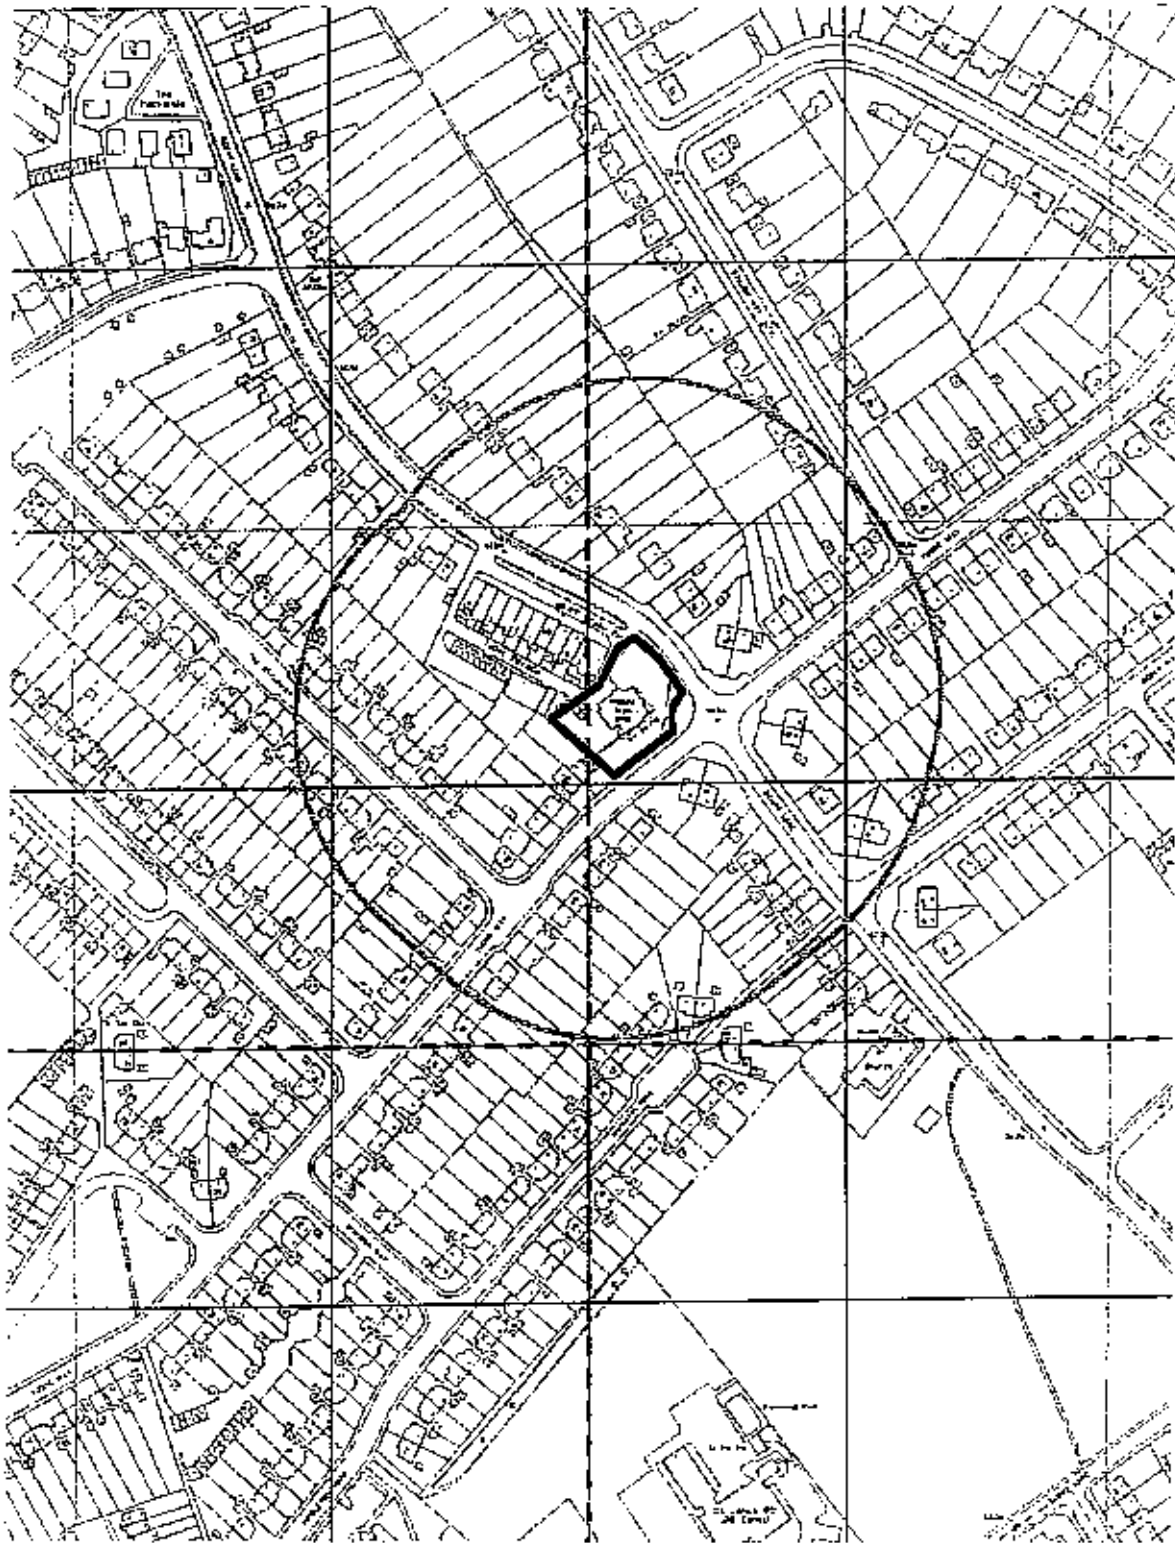
HISTORICAL MAP EXTRACT - 1992

Date	On-site	Surrounding Area
1992 (Fig.7)	The site remains unchanged.	The gravel pits and landfill to the southeast have been replaced by fields. Several houses have now been added to the former chalk pit area to the NW.

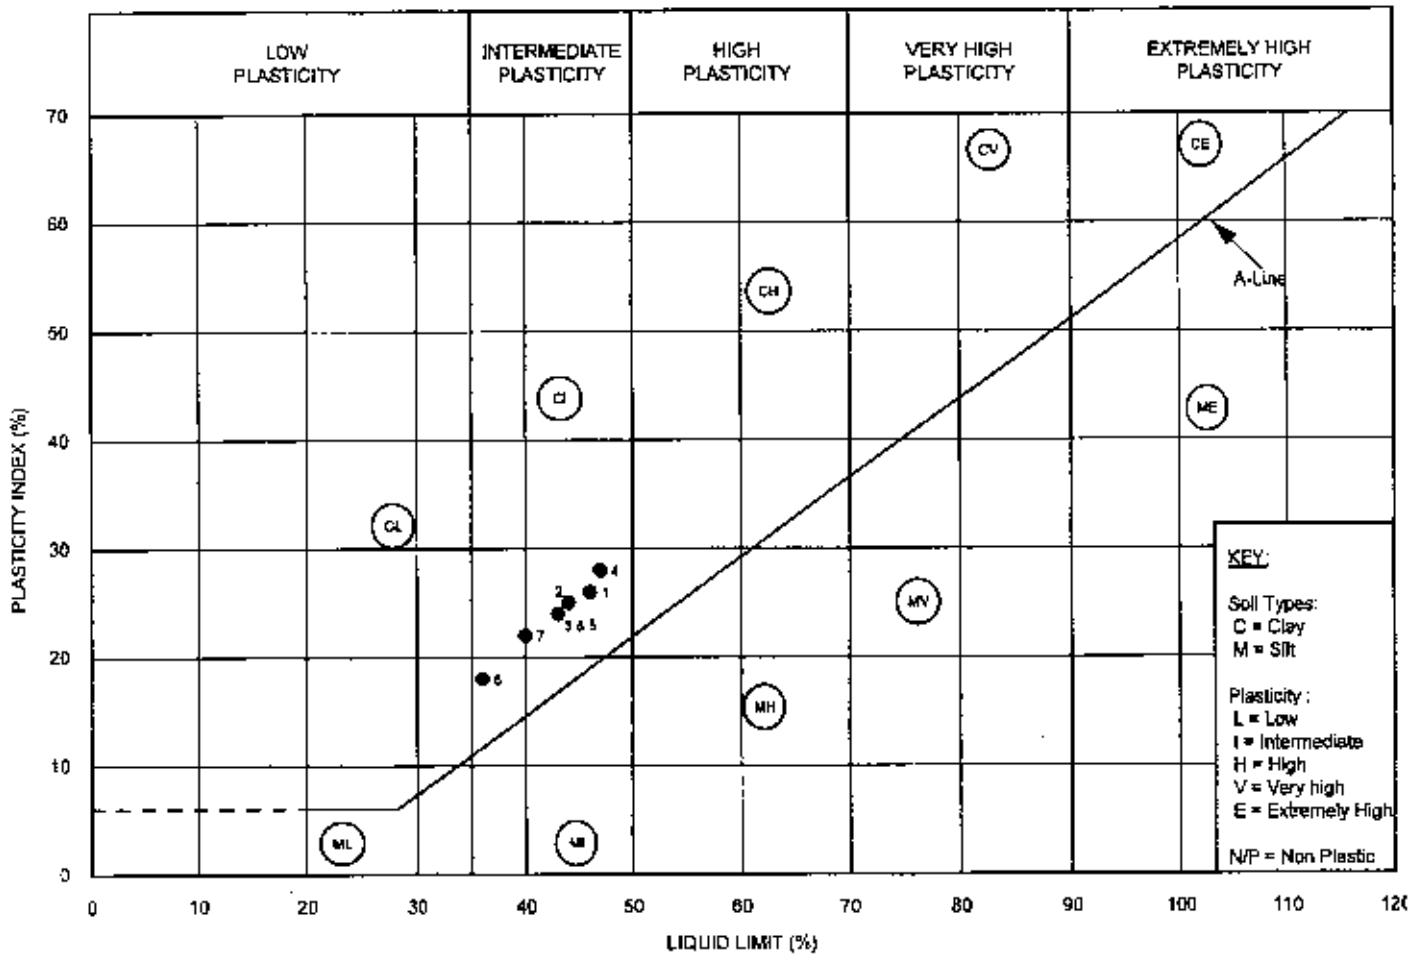
Plot Number	Borehole	Sample	Depth (m)	BS Test Method*	Preparation Method †	% Passing 425 micron Sieve	Liquid Limit (%)	Plastic Limit (%)	Plasticity Index (%)
1	P-H1	-	1.50	4.4/5.3/5.4	4.2.4	46	46	20	26
2	P-H2	-	1.10	4.4/5.3/5.4	4.2.4	40	44	19	25
3	P-H3	-	1.10	4.4/5.3/5.4	4.2.4	56	43	19	24
4	P-H4	-	1.10	4.4/5.3/5.4	4.2.4	65	47	19	28
5	P-H5	-	1.10	4.4/5.3/5.4	4.2.4	33	43	19	24
6	P-H7	-	1.30	4.4/5.3/5.4	4.2.4	70	36	18	18
7	P-H7	-	1.80	4.4/5.3/5.4	4.2.4	52	40	18	22

\*Tested in accordance with the following clauses of BS 1377 Part 2:1990:  
4.3 - Cone Penetrometer Method  
4.4 - One point Cone Penetrometer Method  
4.2 - Casagrande Method  
4.6 - One point Casagrande Method  
5.3 - Plastic Limit Method  
5.4 - Plasticity Index

The results of the laboratory tests, given in Appendix L, indicate the clay to be of low volume shrinkage potential. Based upon the results of the moisture content determinations and the corresponding liquid and plastic limit values, it is considered that at the time of the investigation the clay soils were desiccated within PH1 at 1.50m, PH2 at 1.10m, PH3 and PH5 at 1.10m and PH7 at 1.60m.

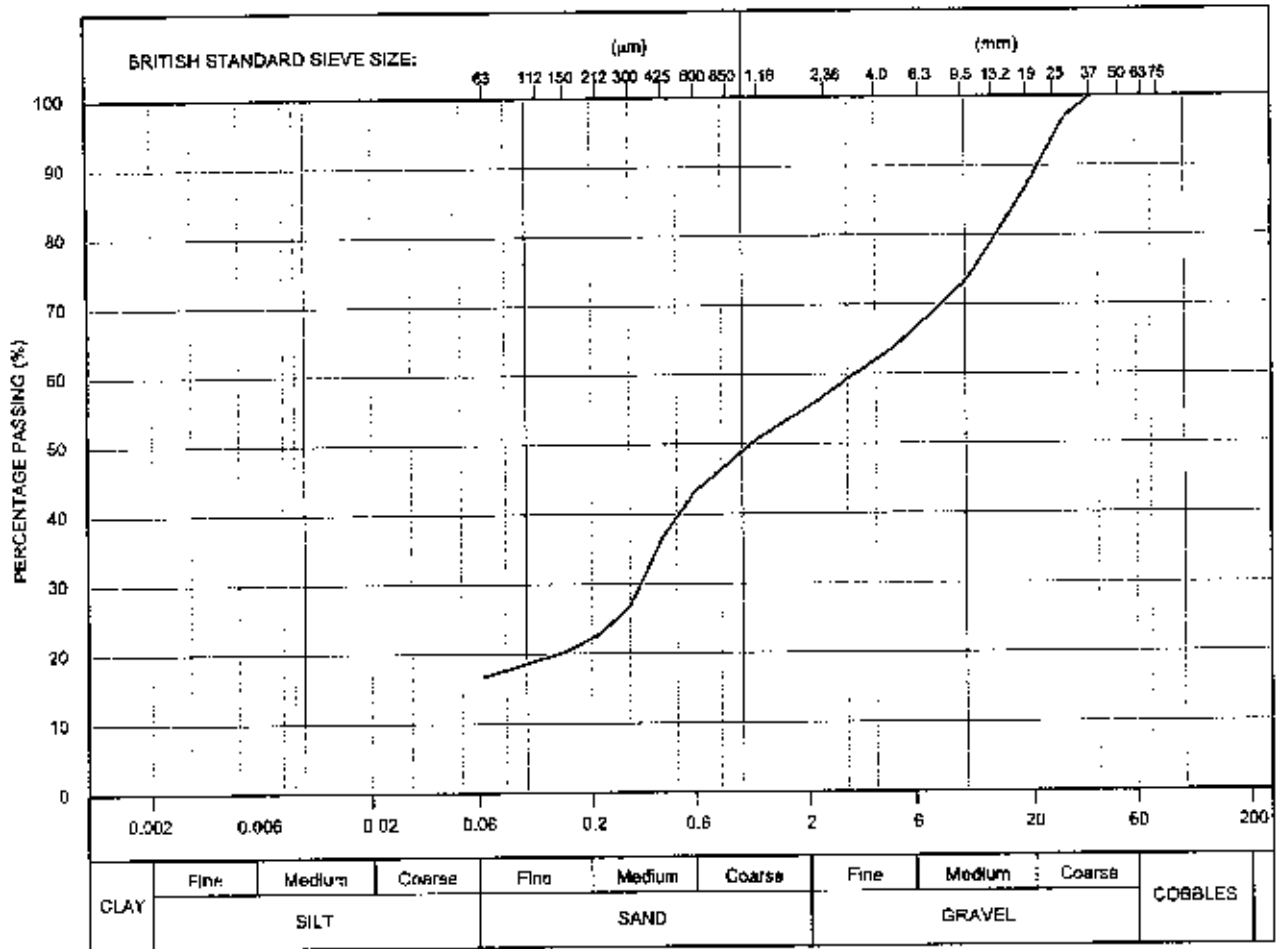
Curve	Borehole	Sample	Depth (m)	BS Test * Method	Pretreatment Method	Percentage soil types				
						Clay	Silt **	Sand	Gravel	Cobbles
1	BH1	-	4.00	9.2	Sodium Hex.	-	17	38	45	-

**Notes:**  
 \* Tested in accordance with the following clauses of BS 1377: Part 2: 1990  
 9.2 Wet sieve                      9.4 Sedimentation by pipette  
 9.3 Dry sieve                        9.5 Sedimentation by hydrometer  
 \*\* Where a sedimentation test was not carried out, this figure represents total fines, i.e., particles of diameter less than 63 microns

The natural moisture contents and liquid and plastic limits of seven samples of the cohesive soils were determined and the particle size distributions of two samples of the granular soils were determined by wet sieve analysis. The results of these physical tests are given in Appendix L.

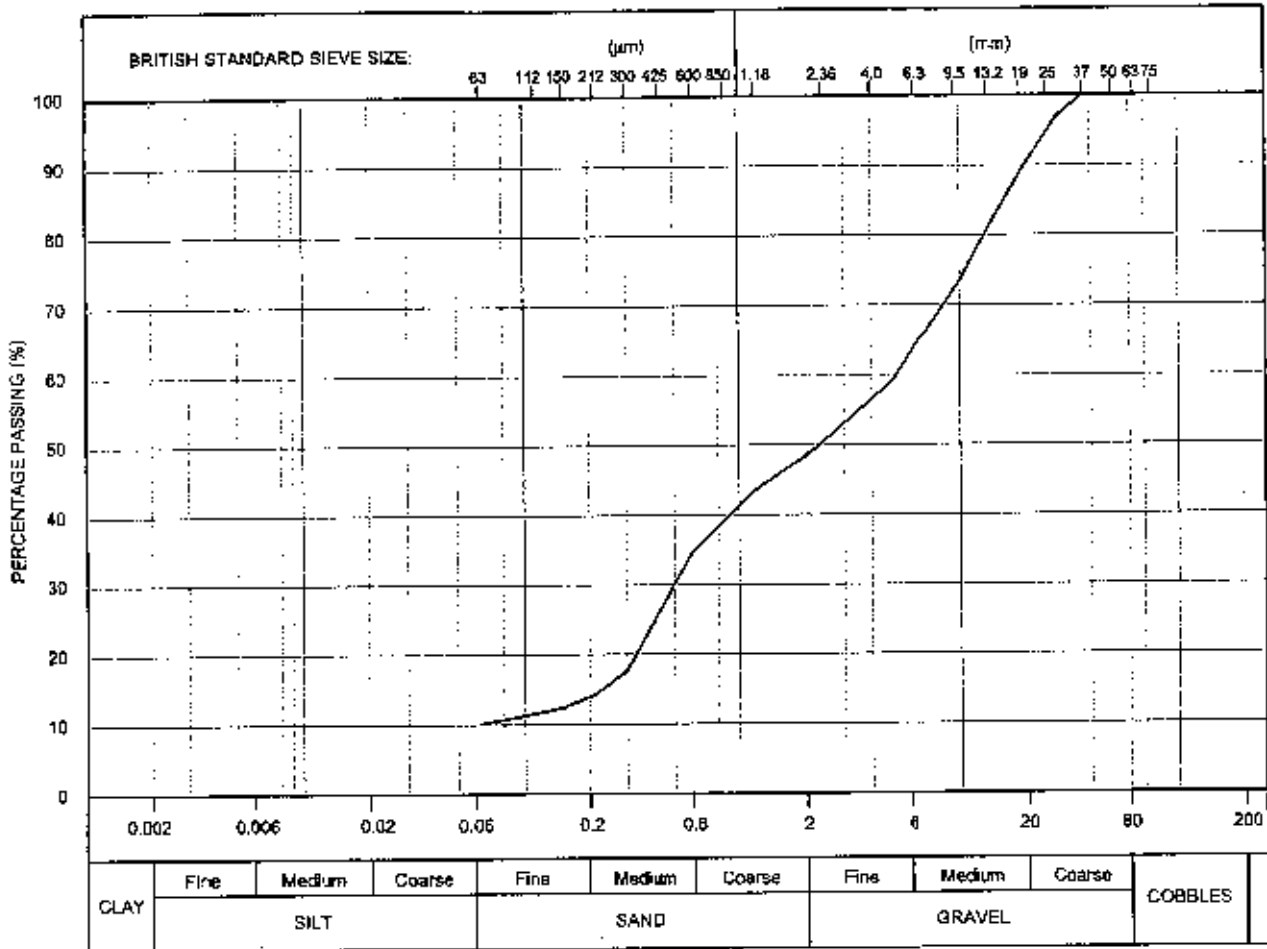
Curve	Borehole	Sample	Depth (m)	BS Test * Method	Pretreatment Method	Percentage soil types				
						Clay	Silt **	Sand	Gravel	Cobbles
1	BH1	-	5.00	9.2	Sodium Hex.	-	10	36	52	-

**Notes:**  
 \* Tested in accordance with the following clauses of BS 1377: Part 2: 1990  
 9.2 Wet sieve                      9.4 Sedimentation by pipette  
 9.3 Dry sieve                        9.5 Sedimentation by hydrometer  
 \*\* Where a sedimentation test was not carried out, this figure represents total fines, i.e., particles of diameter less than 63 microns
